Groundsmaster® 3000 Series

Subject: Idler Pulley Carriage Bolt disengages from adjusting slot

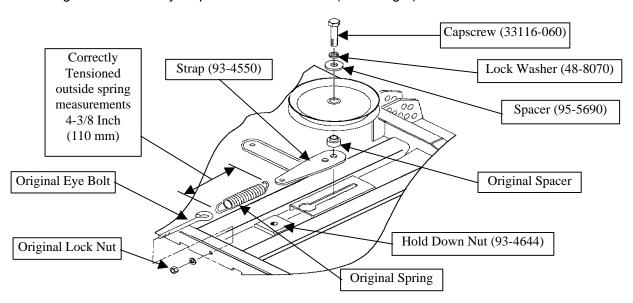
Due variations in belt length and manufacturing tolerances, a properly adjusted deck belt may position the pulley's carriage bolt in, or at the edge of the "keyhole" of the slot and allow the assembly to disengage from the slot during operation. An improved pulley fastening assembly with a special Hold Down Nut is available to prevent this condition on the units identified above. Idler Pulley Kit (93-4699) is available through your local Toro distributor for this purpose. Instructions for installation are included below.

- 1. Remove Lock Nut from Eye Bolt and retain for later use.
- 2. Remove and discard Lock Nut and Carriage Bolt in Idler Pulley (not illustrated).
- 3. Remove and discard Strap connecting Idler Pulley and Tension Spring.
- 4. Slide Hold Down Nut into cavity below "keyhole" slot positioning the chamfered edges of Nut upward against sides of Keyhole Bracket.
- 5. Complete the Idler Pulley assembly as shown below using the Pulley and Spacer from the original assembly and the improved parts (identified with part numbers). Hand tighten the assembly into the threaded hole of Hold Down Nut (keep loose to allow adjustment).
- 6. Attach Spring to Strap and Evebolt and install Lock Nut.
- 7. Position Belt around Idler Pulley and tighten Lock Nut on Eye Bolt until outside length of Spring measures 4-3/8 inches (110mm.).
- 8. Tighten Idler Pulley Capscrew to 75 ±5 ft/lb (10-11 Kgm).
