Customer Service Bulletin Commercial Business Group

ProCore[®] 440, 660 and 880 Aerators

Subject: Pulley Wear Due to Debris Entering Drive Train Area.

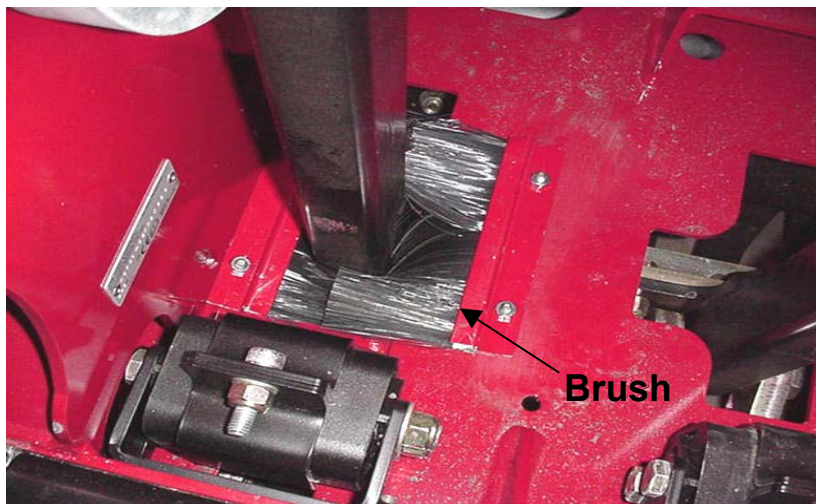
Wear of moving parts, such as the drive pulleys, may occur when debris enters the drive train area. This is especially noticeable in light soil conditions that contain abrasives such as silica sand.

Brush (104-0961) may be installed on each side of the Tine Arm opening as shown below. Two brushes are used for each Tine Arm in the machine. The brushes provide a barrier to reduce direct entry of airborne debris into the area (note, the brushes do not completely cover the opening). Two Screws (321-4) and two Lock Nuts (3296-42) are required for each brush installed. An example of the installation is shown below. Contact your local Toro distributor to obtain parts or for assistance with this bulletin.

1. Position each brush to overlap each other and cover the opening as shown.
2. Use the holes in the brush flange to mark the holes to be drilled in the aerator.
3. Drill ¼ inch (6.4 mm) holes through frame plate in two locations for each brush.
4. Install the fasteners with the nuts at the top.

Note: The holes in the brush need to be enlarged to this drill size also.
