Customer Service Bulletin Commercial Business Group

Pro Core® Series 440, 660 and 880 Aerator

Subject: Belt Slip and Turf Damage due to improper Gearbox Installation.

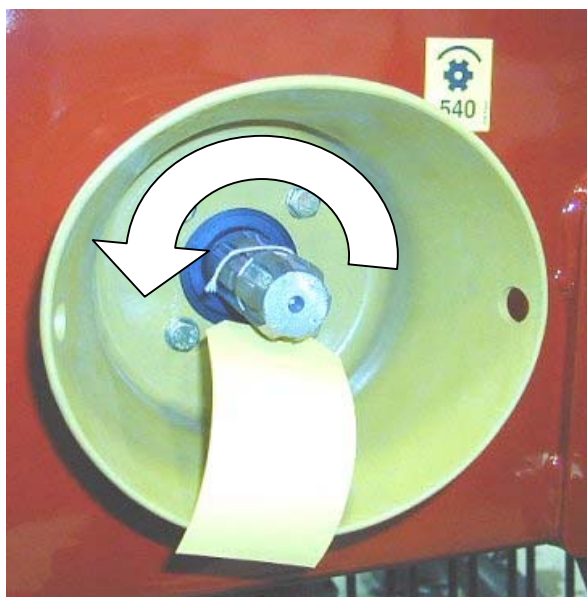
Figure 1

If the belts appear to slip during operation, confirm the belts are adjusted properly as identified in the Operator's Manual. As the gearbox is symmetrical, it can be installed upside down resulting in reversed rotation. Proper installation can be determined by turning the gearbox-input shaft as shown in Figure 1. If the crank arms rotate in the direction shown in Figure 2, the gearbox is installed properly.
