Customer Service Bulletin Commercial Business Group

Greensmaster® Flex 21

Subject: Gearbox Repair Guide for Reel Drive Shaft.

Flex 21 Gearbox repair guide for Reel Drive Shaft

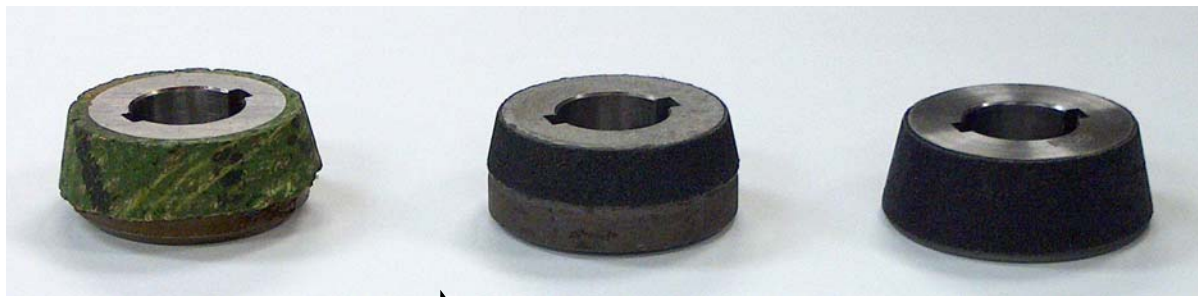
Note: Version is best determined visually by the Cone ASM appearance

Original
(Discontinued)

Version A

Version B

The assembly variations to the reel drive shaft inside the gearbox since the Flex 21 was first introduced can make it difficult to determine the correct parts to use when performing repairs. The Flex 21 Gearbox Repair Guide included with this bulletin is to be used to determine the appropriate parts for repairing the gearbox reel drive system. Regardless of what part combination or order is found inside the gearbox, the proper repair is to install the Version A or the Version B package described in this bulletin.

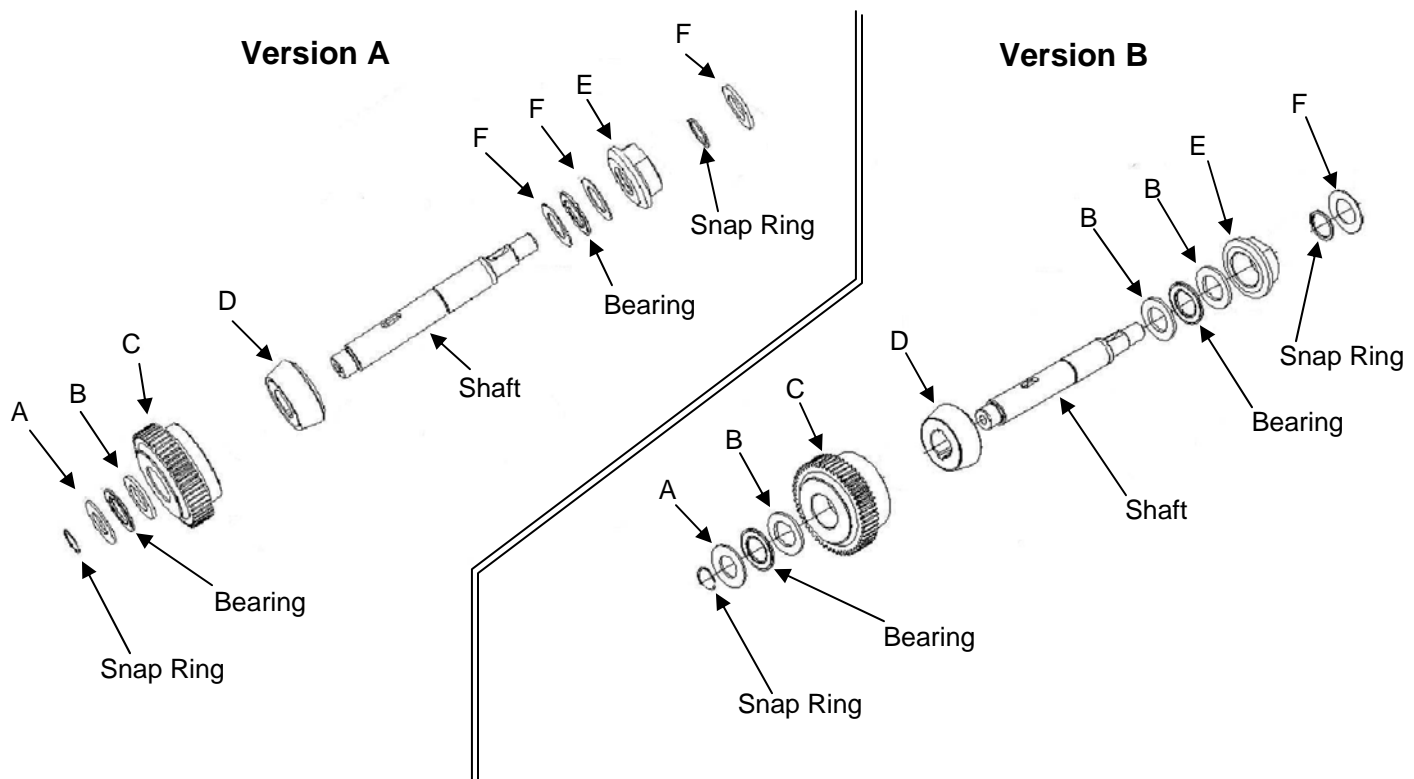
Version A			
Serial Range 210000101-240000601			
Key	Description	Number	Qty
A	Washer (0.062")	99-3806	1
B	Washer (0.092")	99-3807	*1
C	Gear-Clutch	*99-2008	1
D	Cone ASM	*107-7625	1
E	Hub-Plunger	*99-2013	1
F	Washer (0.031")	99-3837	*3

Version B			
Serial Range 240001000 and later			
Key	Description	Number	Qty
A	Washer (0.062")	99-3806	1
B	Washer (0.092")	99-3807	*3
C	Gear-Clutch	*106-8441	1
D	Cone ASM	*107-3232	1
E	Hub-Plunger	*106-8440	1
F	Washer (0.031")	99-3837	*1

Difference between versions is identified in red and with *.

Washer thickness dimension in inches is included in the Description to allow the ability to differentiate.

The serial number ranges identified apply to originally equipped units. This may or may not apply on a previously repaired or replaced gearbox. The figures below identify the position of the spacers and key parts involved to complete the repair of each version. Either version can be installed into a gearbox.
