Visual Differences Between Flex and DPA Bedbars

Product: Flex 21 & Triplex Cutting Units

September 29, 2008

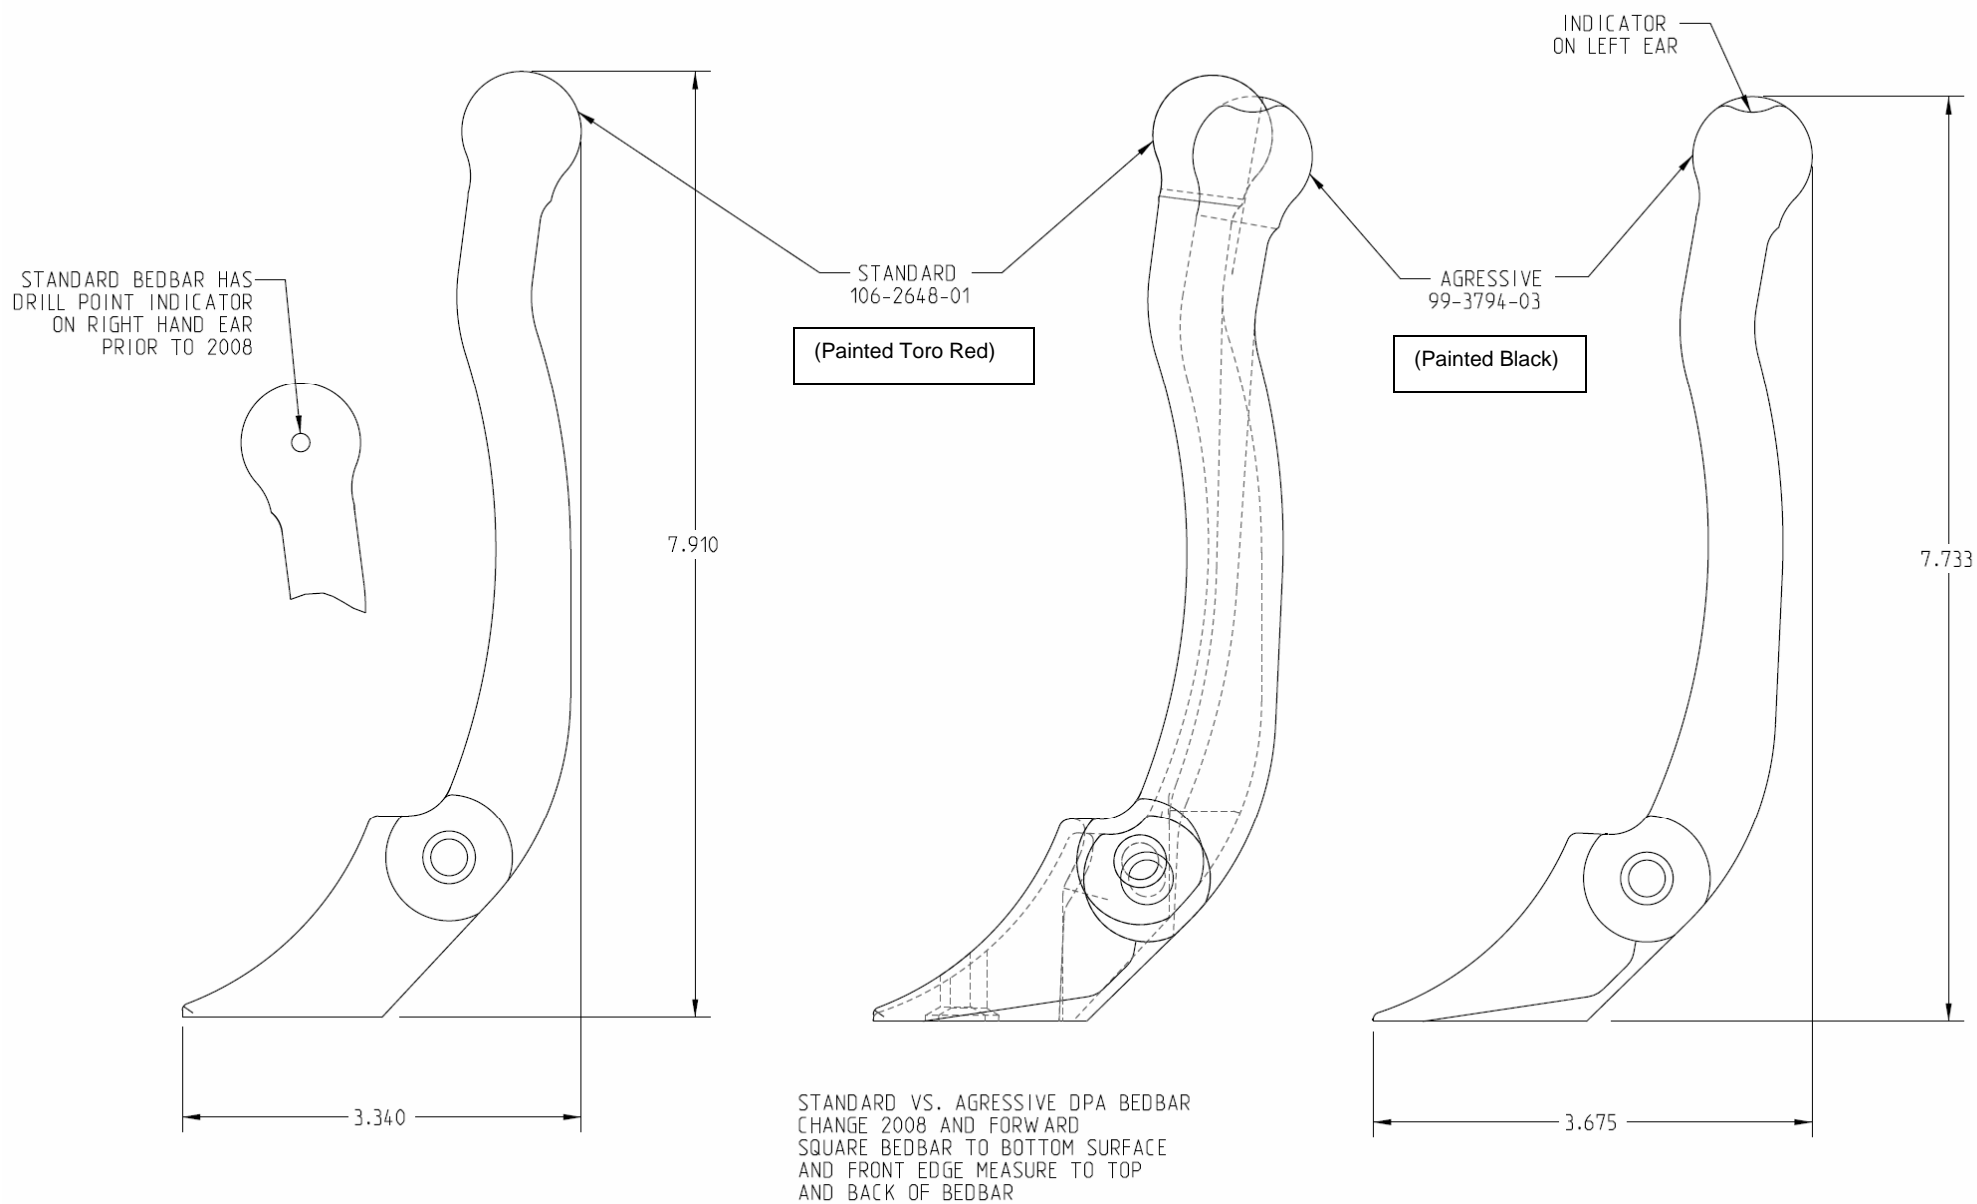
[Aggressive Bedbar \(99-3794-03\)](#) used in Flex 21 cutting units built between 2001 and 2006 (serial numbers 210000101-260009999) were painted red until serial 270009999. After that serial number, all factory installed Aggressive Bedbars are painted black. A crescent shaped portion of the left ear was removed to further visually differentiate it from the Standard Bedbar. (see attached diagram)

[Standard Bedbar \(106-2648-01\)](#) used in all DPA cutting unit applications (230000101 & newer) are painted Toro red. A drill point hole appears in all right ear locations in factory installed bedbars prior to 280000101. All Standard Bedbars produced in 2008 and newer will not have this drill point feature. All Standard Bedbars produced from 2008 and up will be identified solely by red paint.

The last two digits in the part number indicate the paint code color - in this example, -01 indicates Toro Red and -03 signifies black paint.
