## **Greens Reels #08-28**

## **Incorrect Location of Leak Detector Breather**

Product: Greensmaster® 3300 Dec 4, 2012

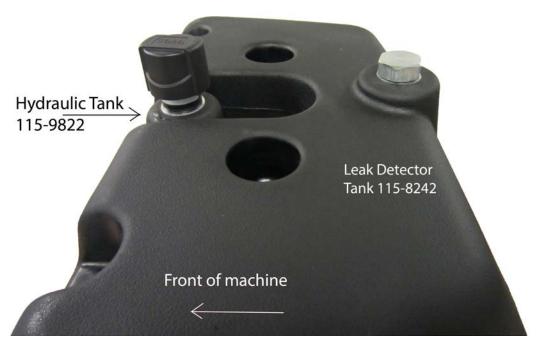
Hydraulic fluid residue could build up on the hydraulic tank from a leaking breather. The Breather (115-9793) on the Greensmaster® 3300 should be located on the Leak Detector Tank (115-8242) while a Plug (354-74) should be on the Hydraulic Tank (115-9822). Some units mistakenly had the breather installed on the hydraulic tank and the plug on the leak detector tank. Below is a picture of a breather installed incorrectly on the hydraulic tank. Note: Failure to make this change may cause a leak or prevent the leak detector to function properly.

### **INCORRECT SET UP**

If the breather is installed on the hydraulic tank, remove the breather from the hydraulic tank and remove the plug (using a 1-1/4" wrench) from the leak detector tank. Install the breather on the leak detector tank and install the plug on the hydraulic tank. Do not use a thread sealant. Below is a picture of a breather installed correctly on the leak detector tank.

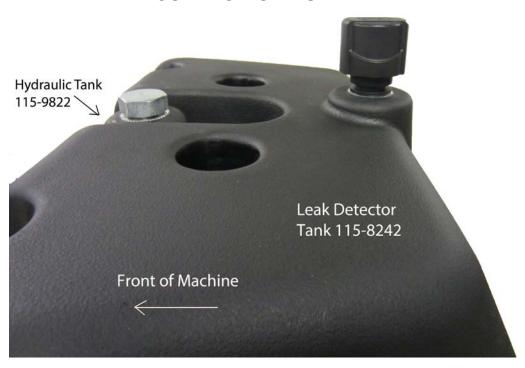
### **CORRECT SET UP**
